**Federal Aviation
Administration**

ADVISORY CIRCULAR

AVIATION MAINTENANCE ALERTS

**ALERT
NUMBER
334**

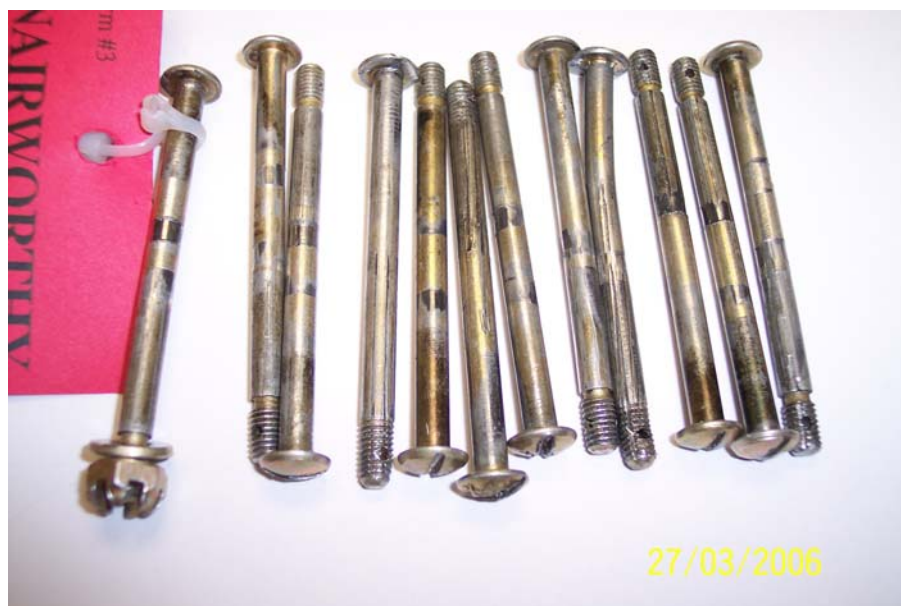
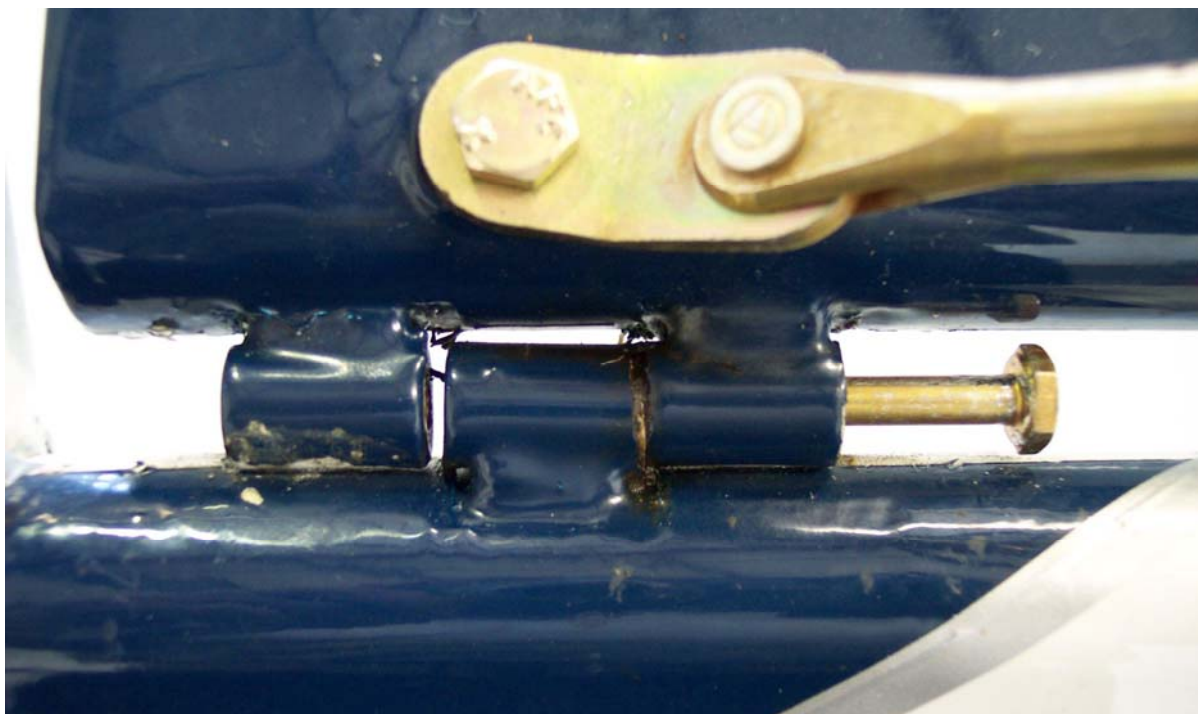
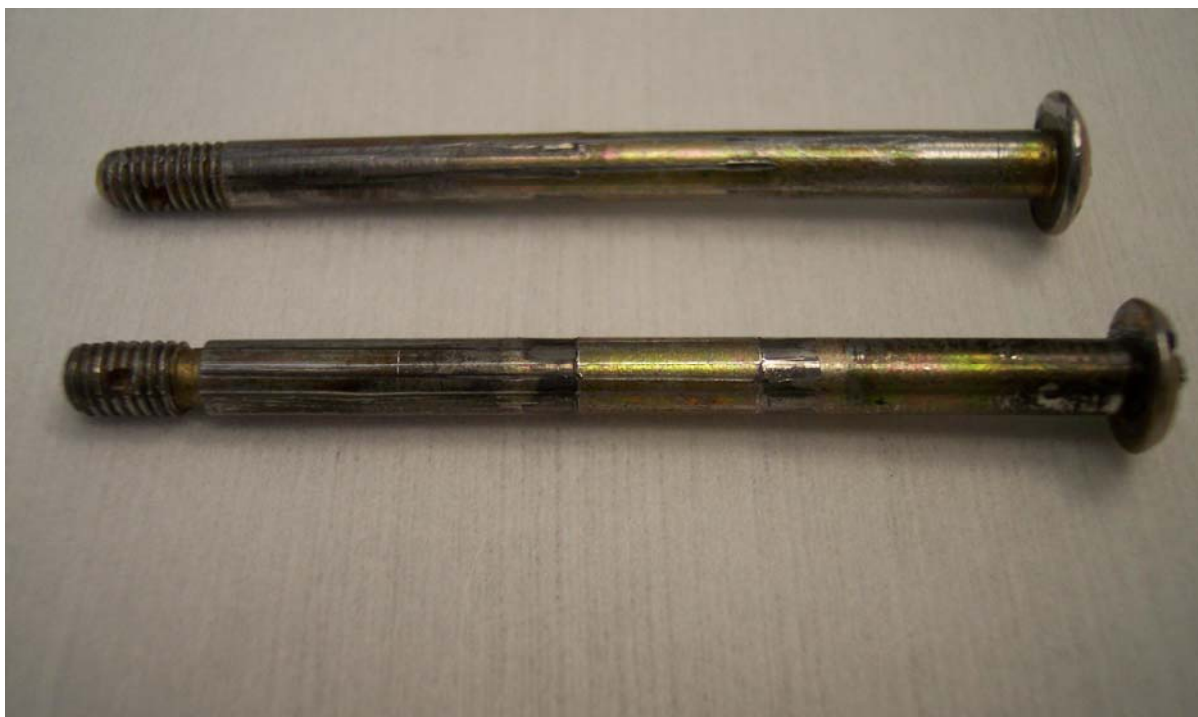
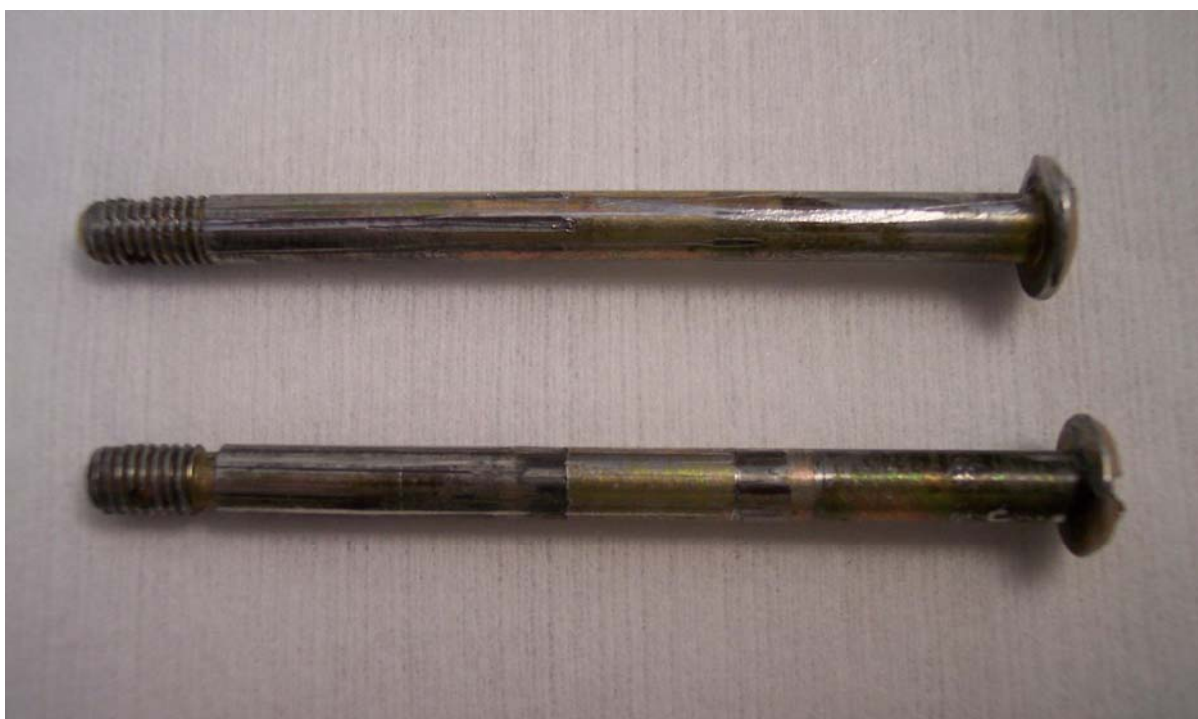
(This report was submitted last year, but personal contact and color photos have provided heretofore unappreciated "depth" of the discrepancy. Also described are the aircraft's rudder hinge bolts--but filed under ATA code 5540.)

Chief Inspector James Kelly of Embry-Riddle Aeronautical University was less than happy in finding the same mechanical discrepancies in two relatively new *Super Decathlon* aircraft under his charge. "During preflight the pilot found excessive movement in the left outboard elevator hinge pin. Maintenance removed both elevators and the rudder and found longitudinal scoring on all the hinge bolts (AN23-40) apparently caused during manufacture of the aircraft. The longitudinal scoring was caused by the center needle bearing (P/N B34PS) on the elevator and the rudder. Circumferential scoring was also present on all bolts apparently caused by improperly aligned and reamed bushings (P/N 1-3737-1) on the horizontal and vertical stabilizer hinges. The manufacturer was contacted concerning this problem. This same condition is present in...(our second aircraft)." "We removed and replaced all bearings and aligned them during installation so the new bolts just slid into the bearings without any force."

(Thanks, Pat, for the very clear photos. Other owner/operators of these aircraft should consider following your actions.)

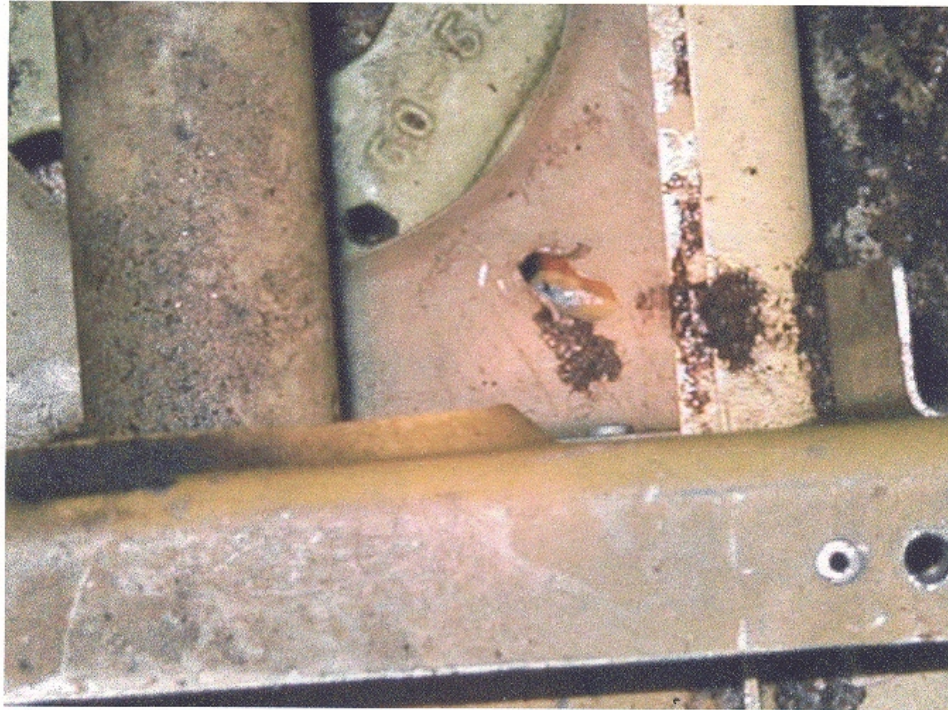
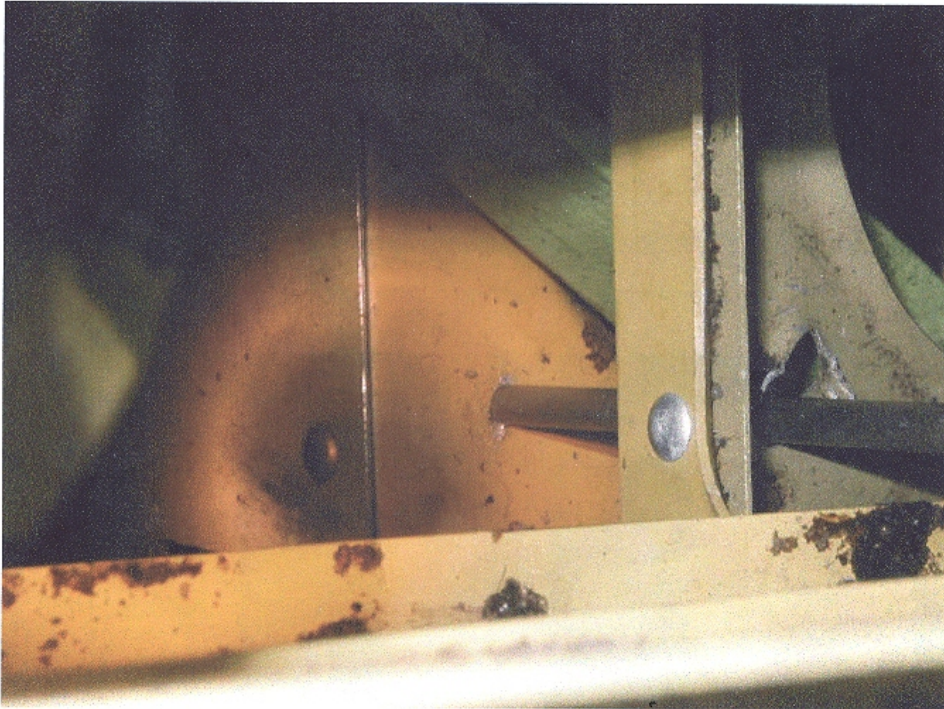
BEECHCRAFT**Beechcraft: 1900C; Damaged Bellcrank Supports; ATA 2730**

“In attempting to rig the elevator system,” writes this mechanic, “it was discovered the rigging hole for the forward elevator bellcrank (P/N 50-420011-77) was damaged in the upper elevator bellcrank support. (Apparently)...the hole had been torn by movement of the bellcrank with the rig pin installed. Additionally, it was discovered the rigging hole in the lower bellcrank support (P/N 50-420011-77) did not exist; i.e., it had never been drilled.” (*Fuselage station number given as 115.3 inches.*)

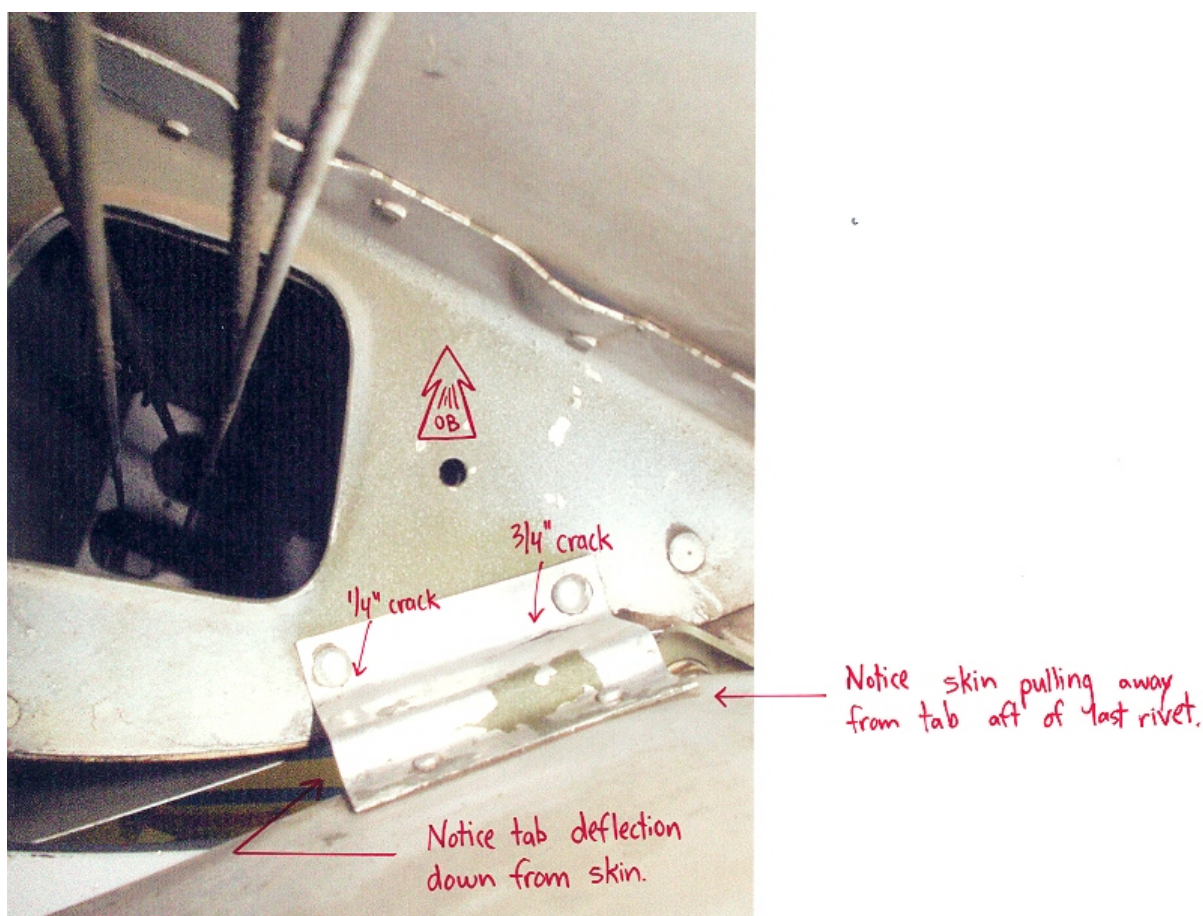
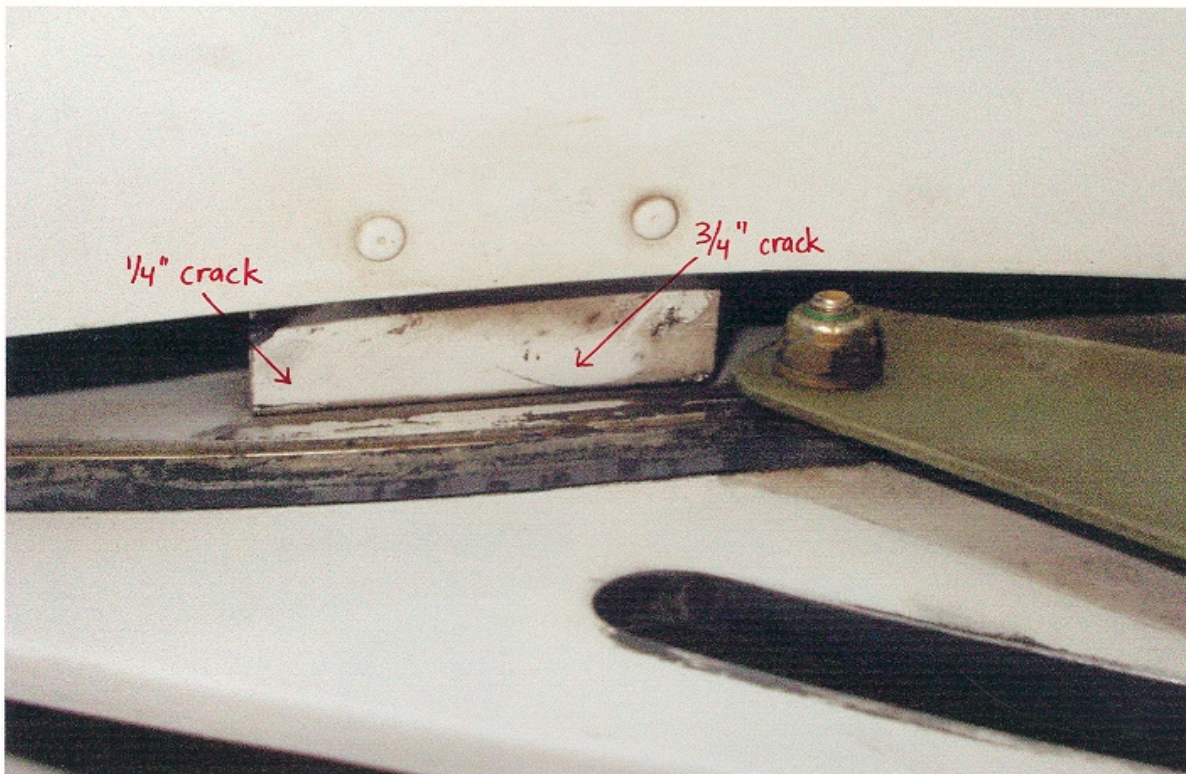
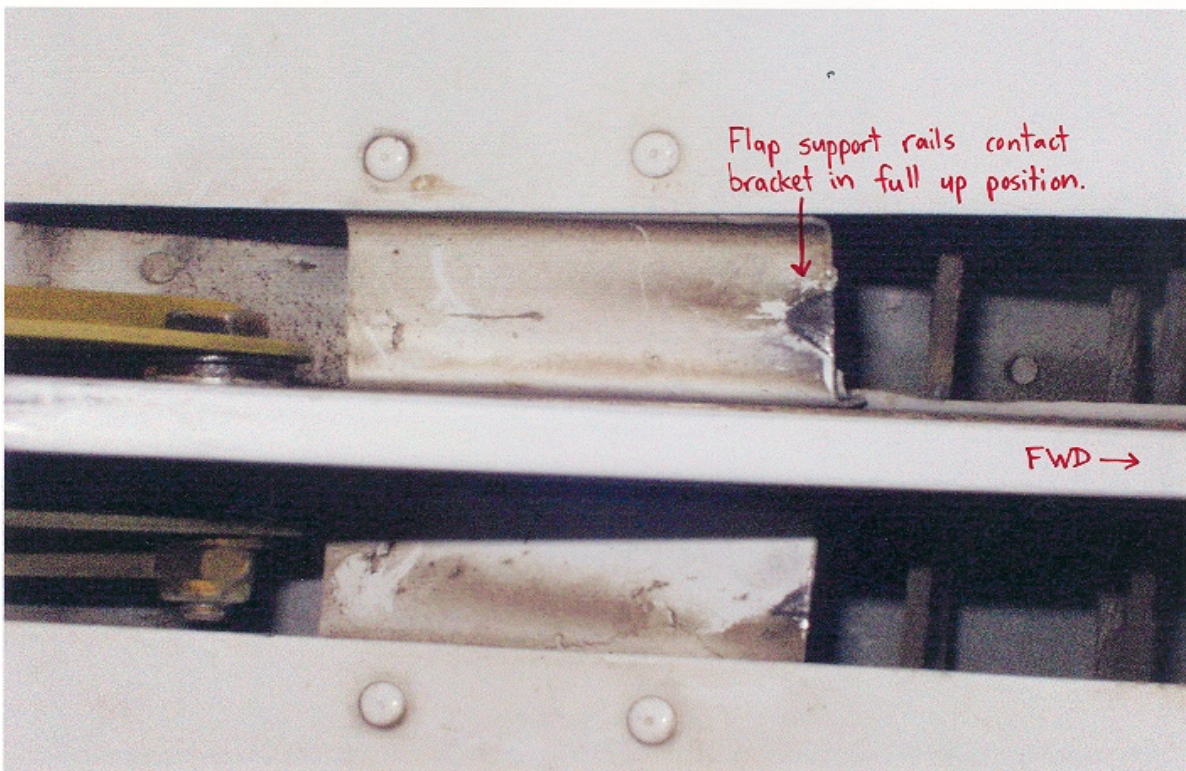
Cessna: 172P; Cracked Bracket—Wing T.E. Skin Support; ATA 5753

This mechanic writes, "The wing trailing edge skin support bracket (*P/N 0523231-24*) cracked in the bend radius. The specific location of the cracked part is inboard of the R/H flap track rib as station 39.0 inches. This part has a $\frac{1}{4}$ inch crack from the leading edge of the tab aft—and another crack in the same bend radius $\frac{3}{4}$ inch from the trailing edge of the tab, forward. The bend radius cracked is the one nearest the flap track rib. The tab appears to be under excessive stress. It is deflected down as viewed from the front of the aircraft facing aft. (*Here*)...the trailing edge wing skin makes a significant increase in it's curve--aft of the last tab attaching rivet--as view from the outboard edge of the skin, looking inboard through the flap track slot. Inspection of our fleet (*including*) Cessna 152(s), a 172, a 172RG, and 182(s) revealed similar conditions on many of the brackets and/or cracked wing skins at the bracket attach point. There is very little clearance between these brackets and the flap support rails. Any cracking or excessive deformation can cause the flap support rails to grab the bracket upon retraction, resulting in failure of the flap and possible loss of control of the aircraft. It is my opinion that a revised flap support bracket be designed and installed in such a (*manner*) as to alleviate the stresses imposed on the bracket and to increase the clearance between the flap support rails and the bracket." (*A search of the SDRS data base yields two similar defect entries. Of course, entering a generic 172 generates 59 assorted entries for this ATA code.*)

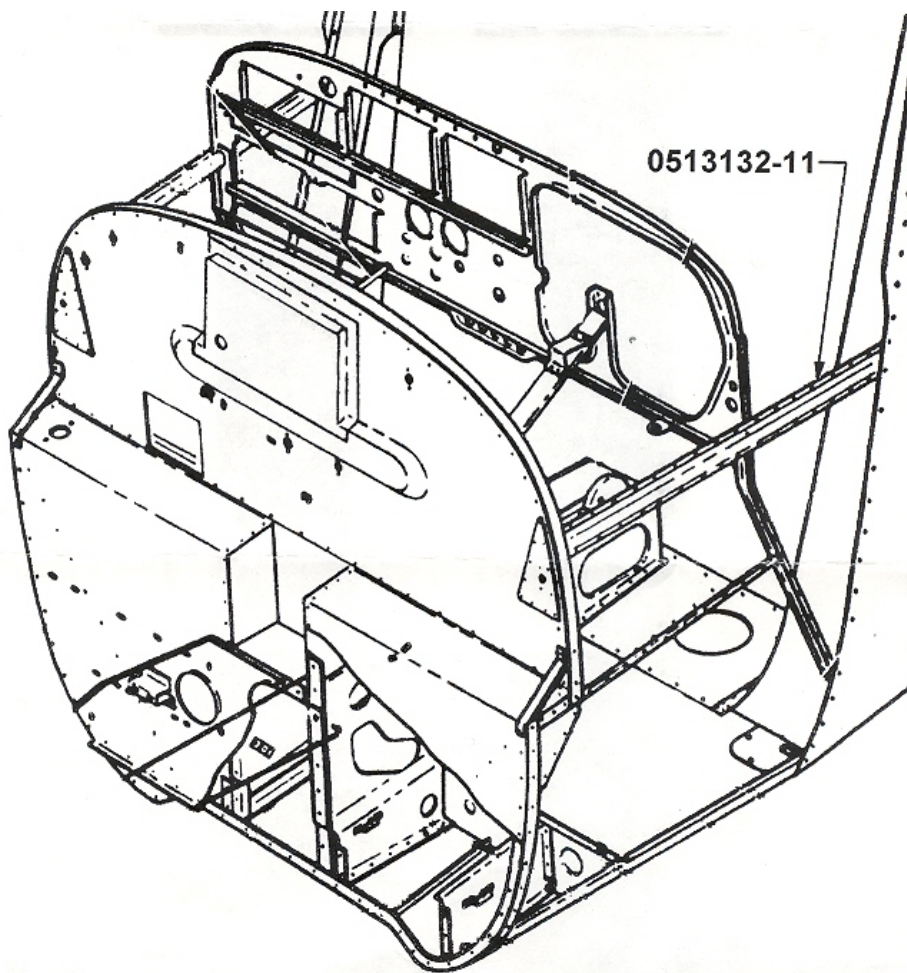
Cessna: Series 172, R172 175; Cracked Engine Mount Attach Bracket; ATA 5313

“The FAA recently received a report of a Cessna Model 175 losing an engine, engine mount and firewall. A close examination of the failure showed that the 0513132-11 bracket had numerous cracks that finally released the upper engine mount attach bolt, producing the failure. A search of SDR's produced 57 reports of failures of -0513132-11 brackets. The brackets were used on Cessna model 172's, 175's and R172's. A disproportionate number of failures were on 175's, R172's, and STC'd 172's, all with heavier engines than the 172's. The 0513132-11 bracket was used from the first 172's and 175 through the 1979 model year. The area is difficult to inspect because the engine mount bolts need to be removed, and the brackets are often covered with insulation.” *(For further information please contact Mr. Gary Parker, aerospace engineer; Wichita Aircraft Certification Office, 1801 Airport Road., Room 100, Wichita, KS. 67209 Phone 316-946-4107.)*

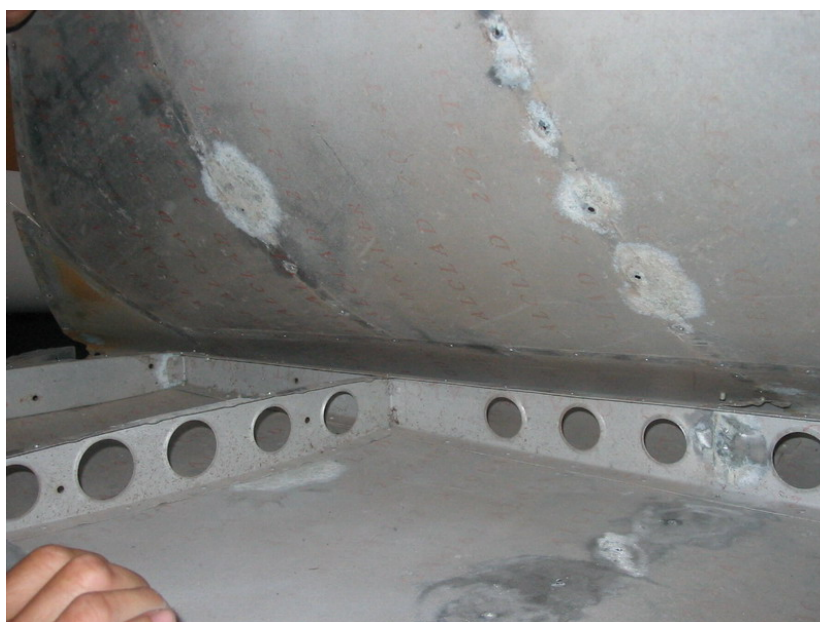
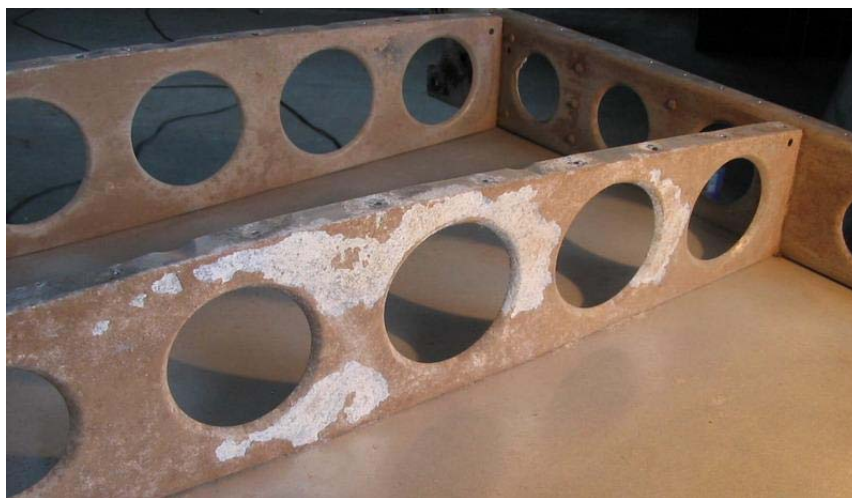
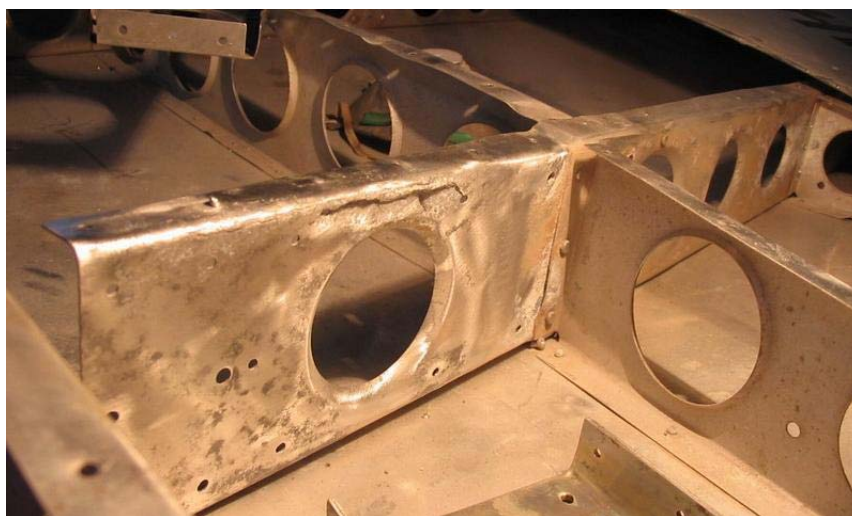
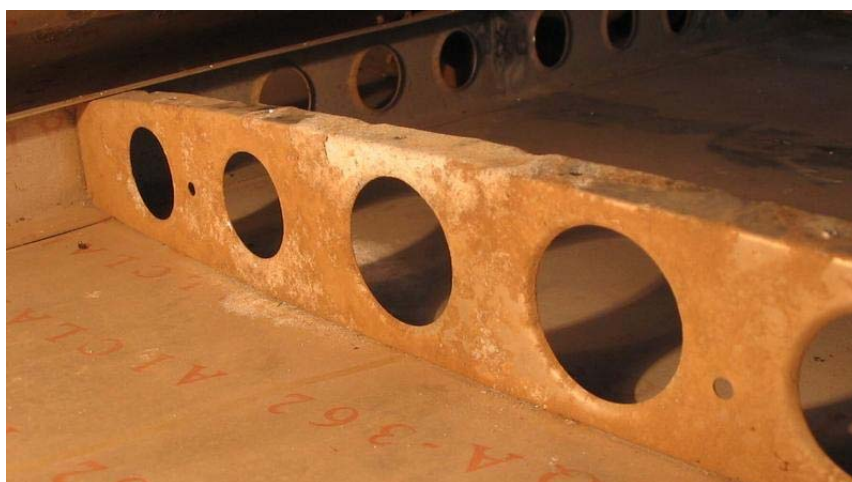
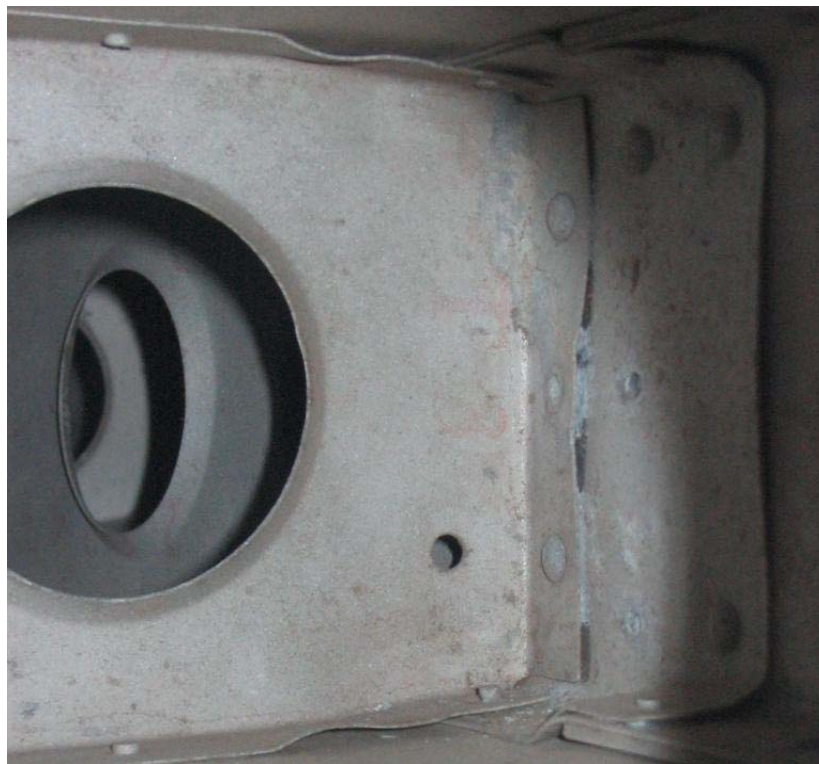
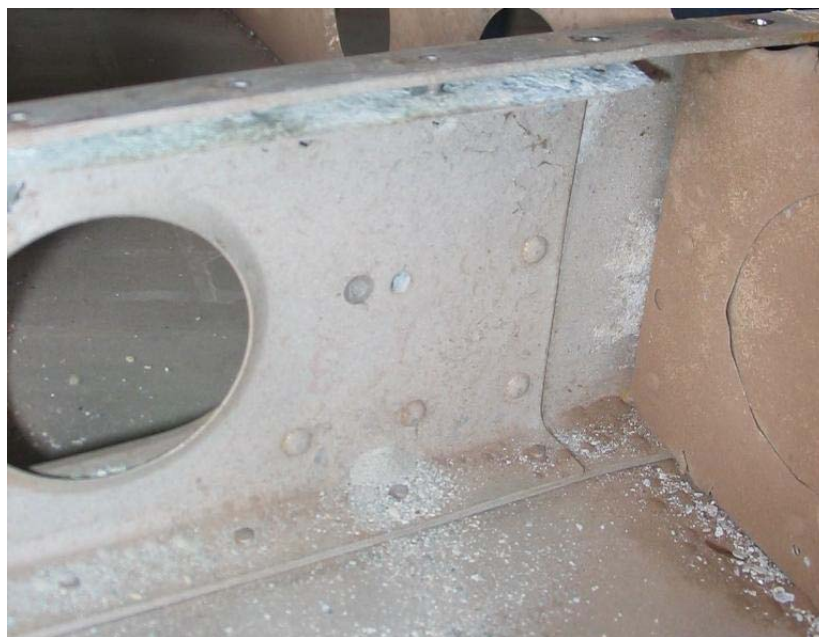
Cessna: 180; Wing Structure Corrosion; ATA 5710

"I would like to tell you specifically about the events...*(concerning this aircraft)*. At the end of 2004, a repair station found severe corrosion in the front and rear wing *(to)* fuselage attachments of a Cessna 180 during a maintenance inspection. There was so much corrosion *(many of the rivets had broken off the wing's rear attachment)*, and when the corrosion was removed many more rivets *(literally—fell out)*.

"(The owner of this aircraft had neglected its proper care and maintenance.) This aircraft has an Aero-Application Kit installed *(agriculture spraying equipment)*, and apparently--it had been in the open for weeks and had not been appropriately cleaned *(...after equipment use.)* *(In the beginning we thought...)* the corrosion resulted from the products used for spraying, but the kind of corrosion found and the areas in which it was found evidenced this corrosion originated from exposure to the environment and lack of maintenance and cleaning for years on the part of the owner.

"At present, the aircraft is being maintained *(literally—the wing corrosion defects are being repaired. During this effort the vertical stabilizer was also removed and opened—more significant corrosion was found)*. I was there when these tasks were being performed and took pictures *(of these defects)*. As can be seen in the pictures, the corrosion found in the *(vertical stabilizer)* is of the same kind found in the *(wing)*. Some of these parts were really deteriorated—*(to the extent the rivets were broken off)*. These parts are made of 2024 T-3 Alclad aluminum and do not have any other corrosion protection measures—*apart from the clad*.

"After doing some research we have learned this kind of corrosion is frequent in these Cessna 100 series aircraft.... Given the aircraft fleet in our country has many aircraft which are older than 30 years, we are *(motivated)* to take preventative actions."

(Thank-you for the scary photographs! Corrosion detection, removal, prevention and repair for general aviation aircraft lies within the responsibility of the owner-operators, mechanics, and inspectors. Those of us who fly small Cessna aircraft pine for the days when new 150 series could occasionally be seen—even rented. All of us who participate in small aircraft operation need to be vigilant about corrosion—it's eating the last of our once-affordable airplanes into extinction: hence, light sport.)

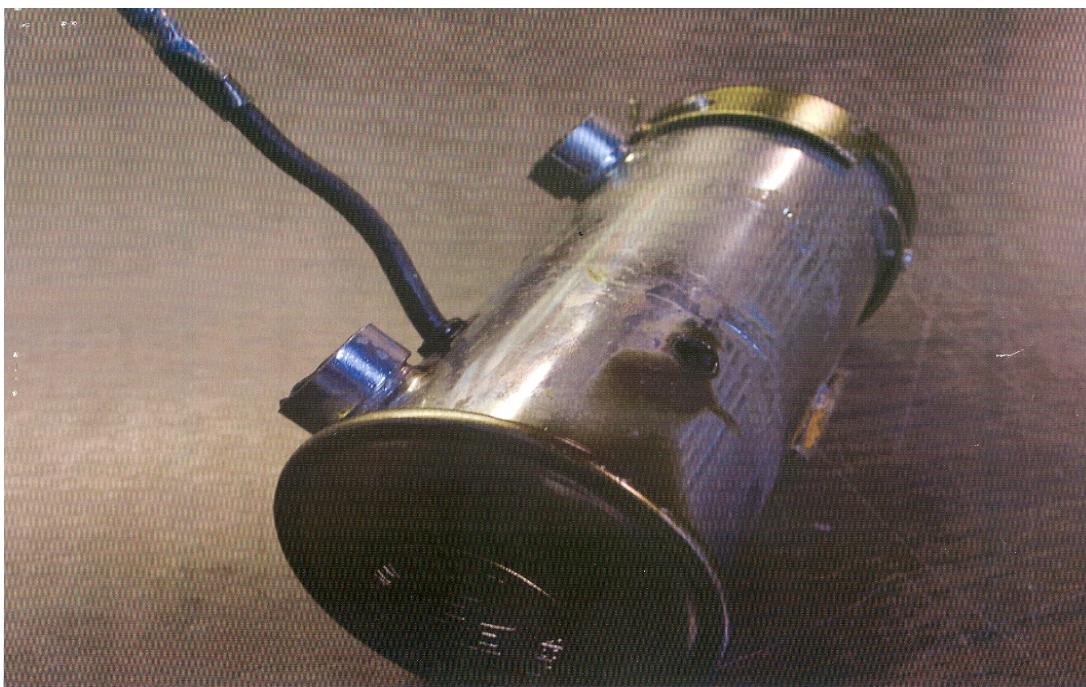
Cessna: 421B; Malfunctioning Heater Fuel Pump; ATA 2140

“The pilot reported the heater had stopped during flight,” states this mechanic. “After returning to the maintenance shop the heater was troubleshot and inspected. We found the heater fuel pump had malfunctioned and had caught on fire for *(an undetermined)* time. We were able to say it was on fire because of the burn marks on the outside of the pump housing. I have enclosed 2 photographs to show this. *(One is shown below.)* I contacted C&D Associates to ask about this problem and I was told that they know about this and *(they)* have talked with the pump manufacturer Genuine Facet Corporation *(about designing)* a new style pump. C&D Associates Inc. says the problem is with the Parker Fuel Regulator in the wings on the Cessna 400 series. The regulators seem not to allow enough fuel to go through to keep the pumps operating correctly—allowing them to overheat and fail.” *(The picture has been compressed vertically.)*

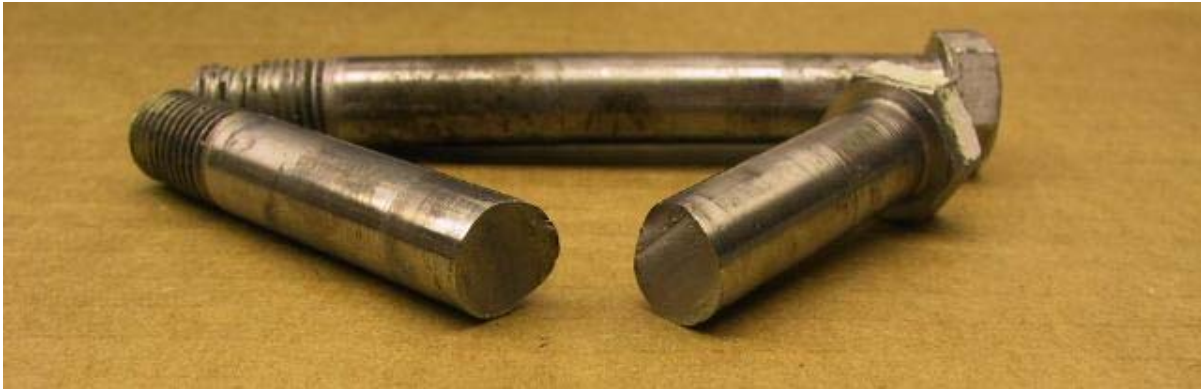
PIPER**Piper: PA23-250; Broken Main Landing Gear Link Bolt; ATA 3213**

Mechanic Dennis T. writes, “P/N 402-427 bolt broke on landing. This bolt is in the *(landing gear link assembly)*, P/N 16240-5. The right main gear folded aft—the tire rode on the right flap.” *(A total cost of the damage in time, parts, and labor would be interesting as compared to a \$10 bolt replacement every 2,000 hours. What’s the cost if someone gets hurt next time? PA28 owner/operators--all such aircraft with similar scissors links—should look carefully at these pictures, and note the aircraft time. The SDRS data base reflects at least two additional/similar bolt failures.)*

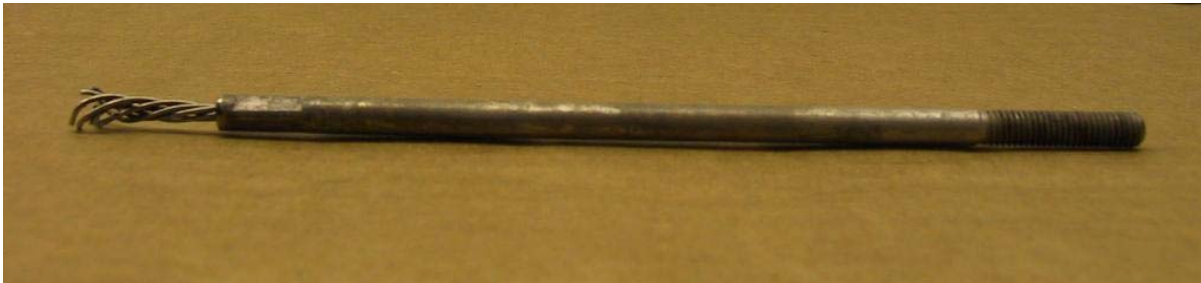
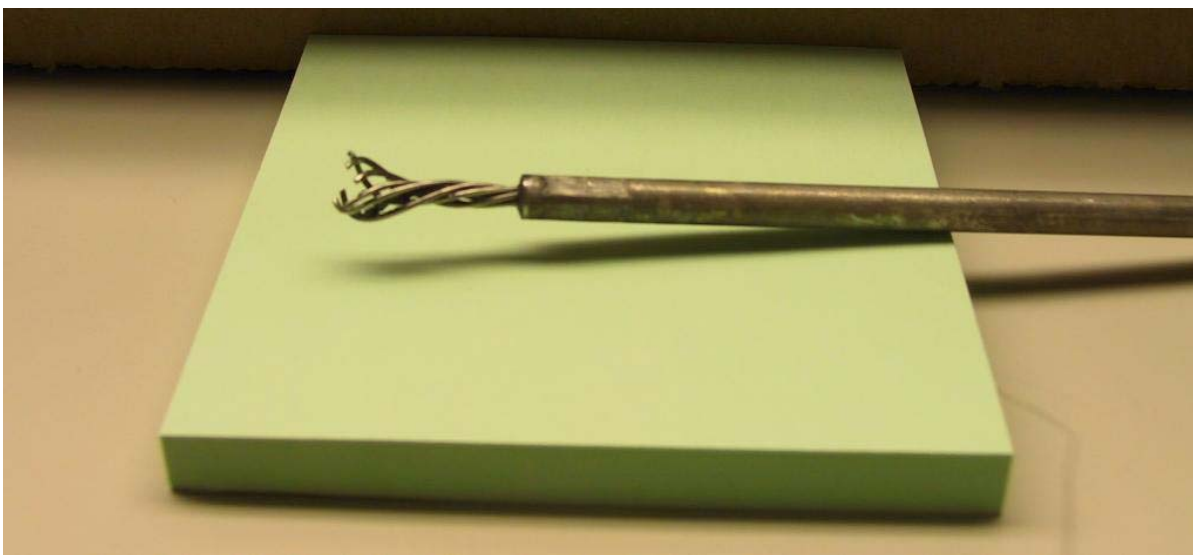
Piper: PA23-250; Broken Mixture Control Cable; ATA 7602

“The mixture cable (P/N 30205-08) broke at the control lever end. The seven strand inner cable parted $\frac{3}{4}$ inch from the push/pull slider cable end. Cable strands appear to have been ballooned from over compression/over travel. The cable parted at engine shut down. The replacement cable is P/N 454-204 and may have been improved over the original.” *(The SDRS data base records an additional two entries of mixture/cable problems.)*

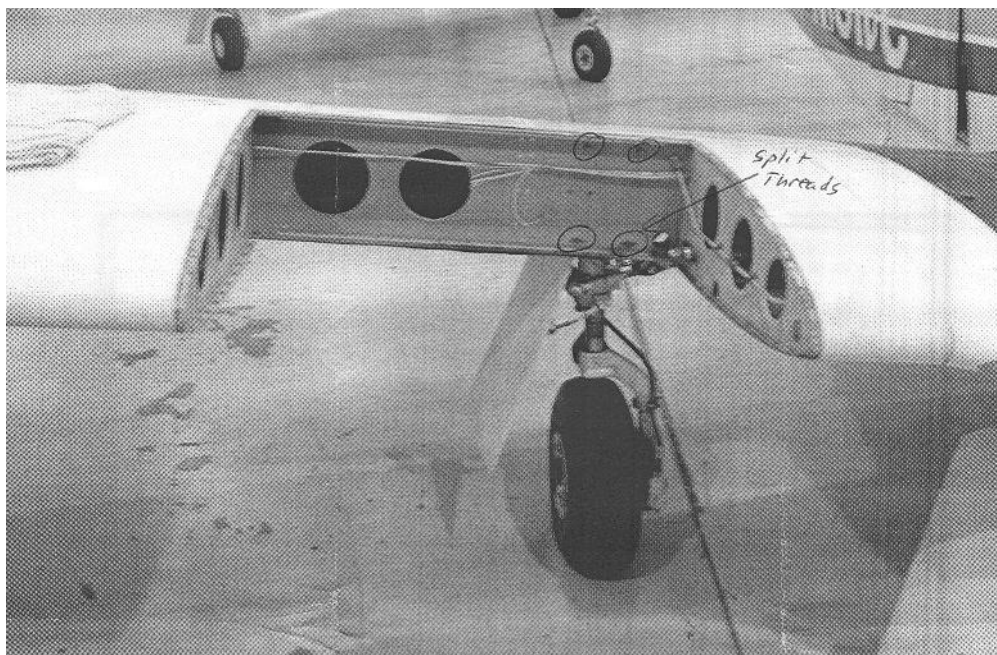
Piper: PA28R-200; Cracked Landing Gear Nutplates; ATA 3211

The submitting mechanic writes, "After removing the right fuel tank for repair, it was discovered all four nutplates holding the forward main landing gear trunnion bolts were cracked. The lower inboard nutplate (*P/N MS 21047-L4*) was cracked vertically down the threads. The remaining three nutplates were cracked in the rivet tabs. This aircraft is a training aircraft that sees its share of hard landings. Probable cause is fatigue from repeated (*hard*) landings. The left fuel tank was removed as well to inspect the left main landing gear trunnion nutplates. No cracks were found on the left side. Periodic inspections may be required to ensure the nutplates are serviceable." (*Good catch, Andrew! I suspect more than a few owners will specifically add this to their inspection list. However, the SDRS data base does not return additional/similar findings for landing gear nutplates—but if everybody is now looking for them....*)

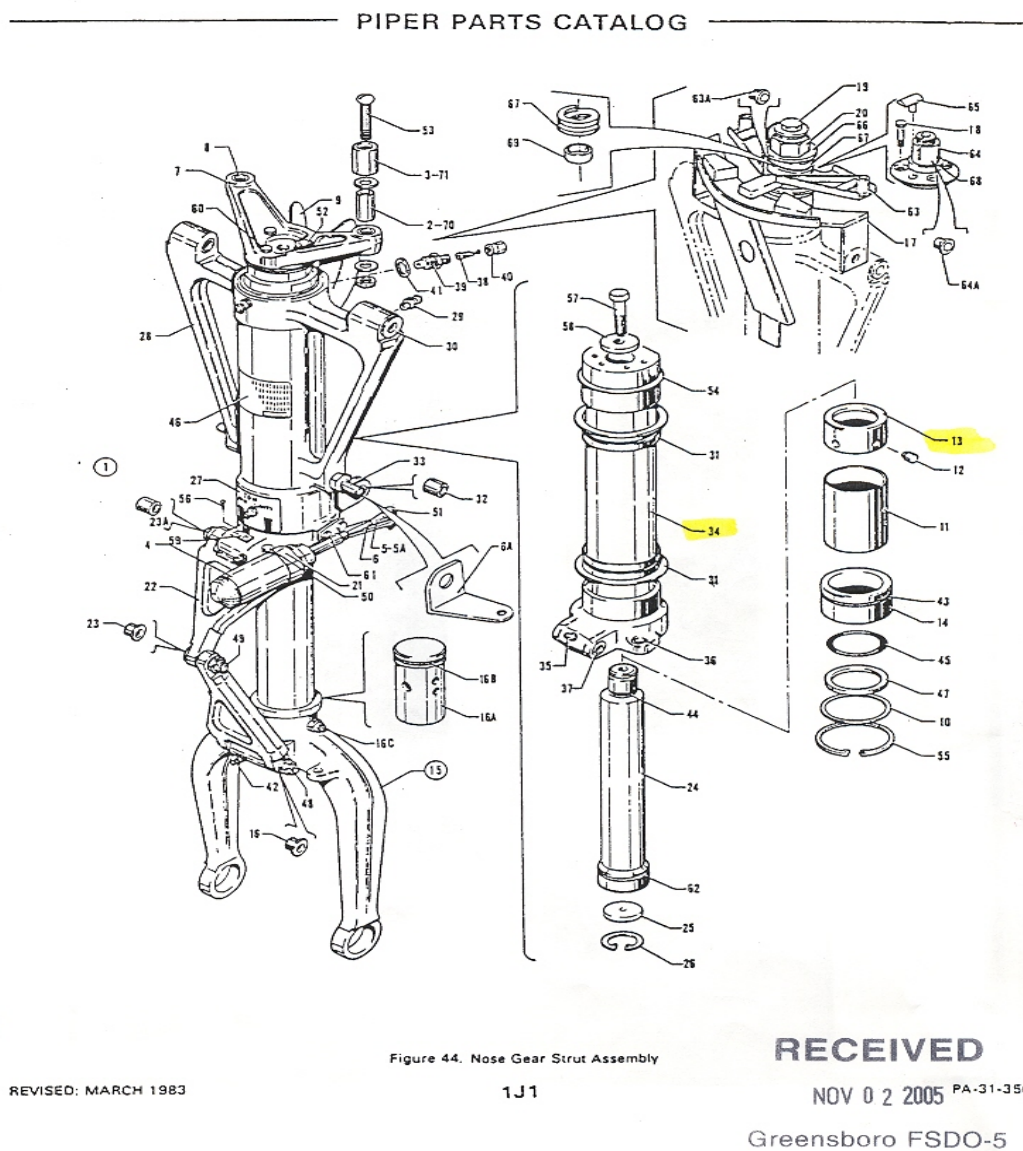
Piper: PA31-350; Mis-bored Nose Gear Cylinders; ATA 3222

A mechanic states he (or his company) "...purchased two new nose landing gear cylinder assemblies with incorrectly machined center bores (P/N 45314-05). The bore of the cylinders are too small at the top which doesn't allow the upper bearings (P/N 751363) full travel to the top of the cylinder. This could cause the bearings to jam in the bore and the landing gear to malfunction upon retraction/extension."
